NASA Technical Paper 1961

December 1981

Thermal and Aerothermal Performance of a Titanium Multiwall Thermal Protection System

Don E. Avery, John L. Shideler, and Robert N. Stuckey

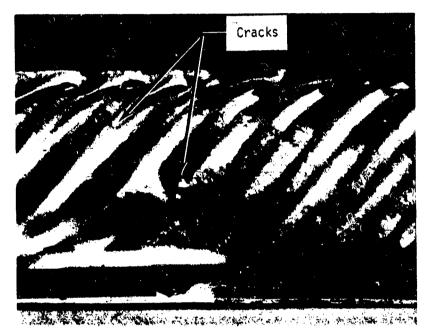
L-81-255

At the conclusion of the test series, the aerothermal model was disassembled to examine the individual tiles. Figure 29(a) shows top surface cracks on tile A. The cracks occurred in the downstream corner of the tile where previously mentioned fabrication difficulties associated with the edge closures occurred. Additional damage occurred on the top surface where small particle penetrations were caused by rust particles in the wind-tunnel stream. Cracks in the lower surface lip and in the corrugated side walls of tile A are shown in figures 29(b) and (c). None of these problems resulted in TPS failure, and all this damage occurred in multiwall tiles which interfaced with the Glasrock as opposed to the center tile which interfaced solely with other multiwall tiles.

(c) Cracks in corrugated edge closure.

Figure 29.- Concluded.

Minor design changes in the multiwall TPS have been identified to remedy the problems discussed above. The structural integrity should be improved significantly if the scarf angle relative to the face sheets is increased and if the node size of the dimple bond is increased. Buckling of the lips could be reduced by not staggering the alignment of the tiles so that thermal displacement of adjacent tiles are more compatible at the tile boundaries. Finally, use of the stronger Ti-6Al-2Sn-4Zr-2Mo alloy in place of Ti-6Al-4V alloy should help prevent permanent deformation of the lip. These changes would have a negligible impact on the thermal protection ability and mass of the multiwall TPS.
